Osmania General Hospital,

Hyderabad, Telangana, India.

INSPECTION REPORT (*Structural Stability/Safety*) August 2015

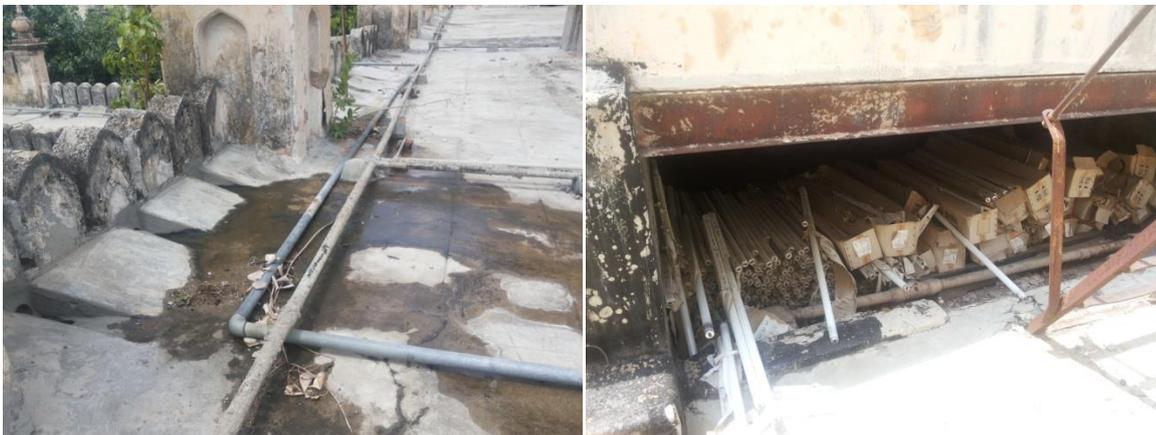
Leaking pipes and debris on terrace.

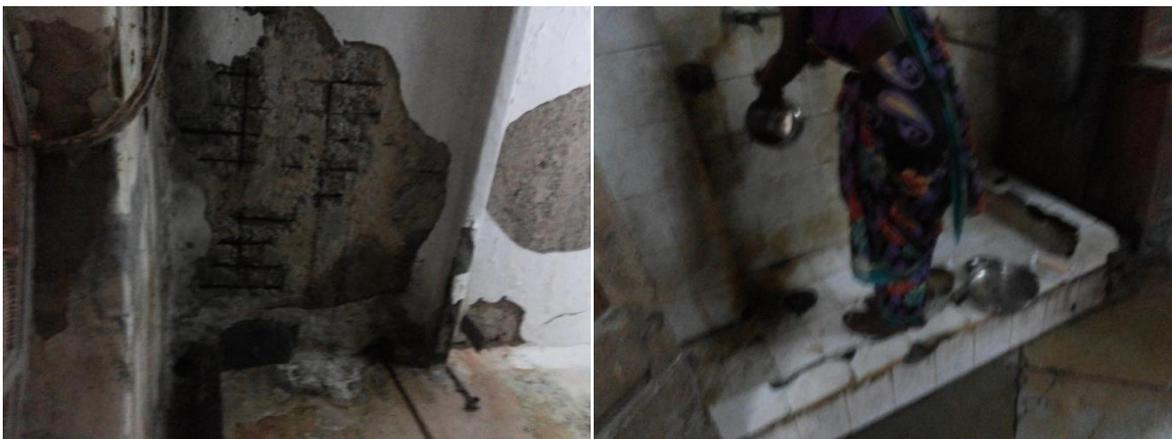
Plaster peeling and corrosion of slab due to washing facility located above it.

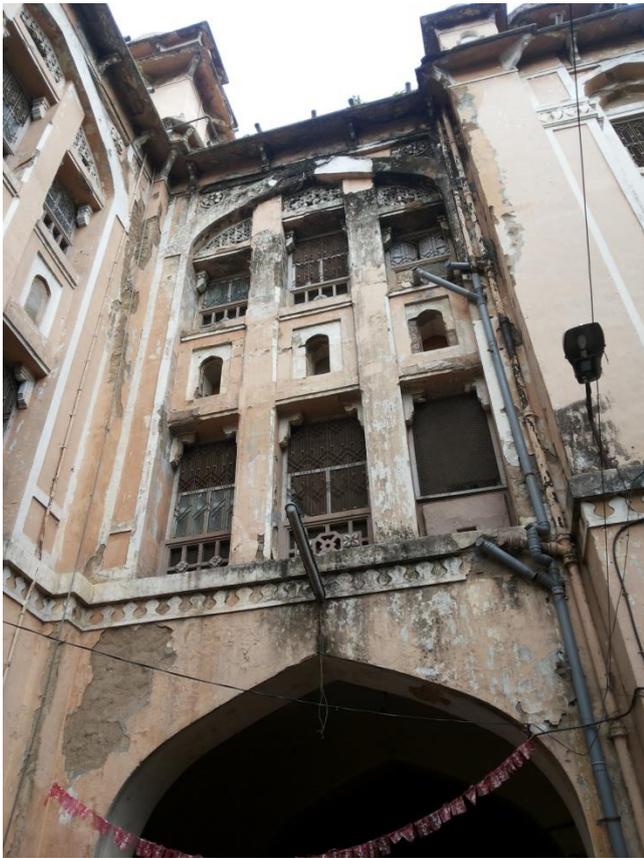
Leaking or broken down pipes causing dampness and peeling of plaster

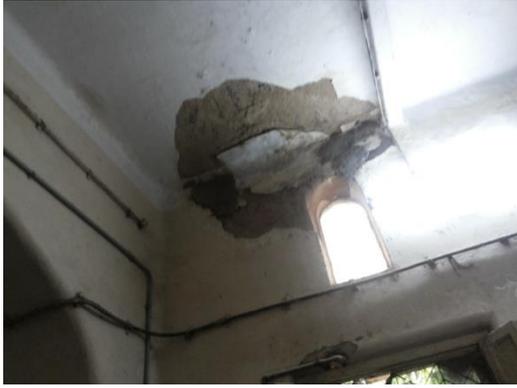
This is caused mainly due to the effect of dampness arising out of water seepage from leaking pipes and drains, and faulty water proofing on the terrace. The ingress of water has resulted in rusting and spalling of structural steel in a few places leading to the plaster peeling off and falling down.

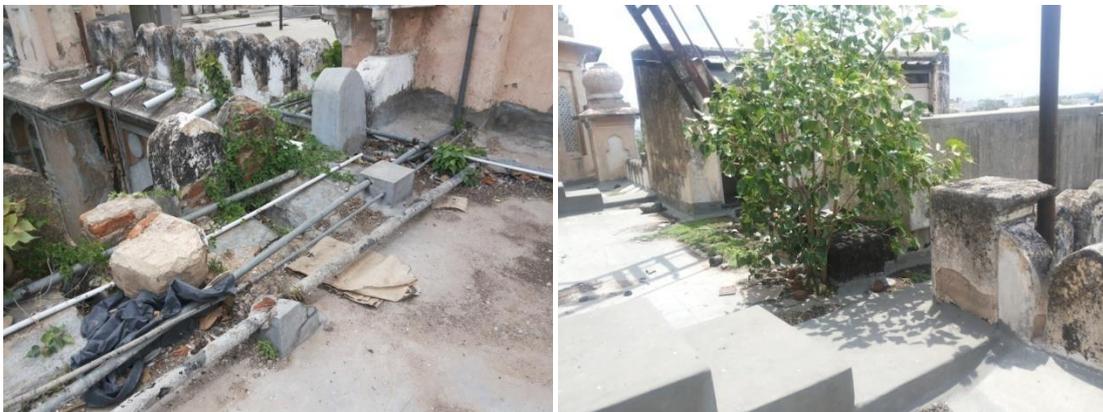
Vegetation Growth on terrace

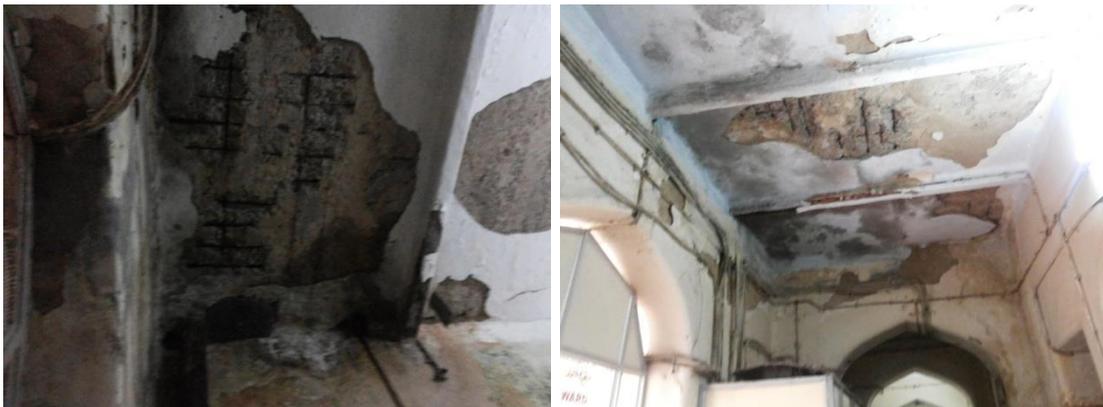
- **Corrosion of Steel Members:** The bottom reinforcement of the roof slab in the building is corroded at places especially in the first floor. This is a localized distress caused primarily due to seepage of water from washing areas and from leaking pipes and drains of water coolers and toilets located on the floor above. The spans of such distressed areas are small, the panels at the most being 2mts x 3mts. These areas can be isolated and repaired easily without in any way impacting the overall stability of the structure.

Corrosion in RCC slabs due to seepage

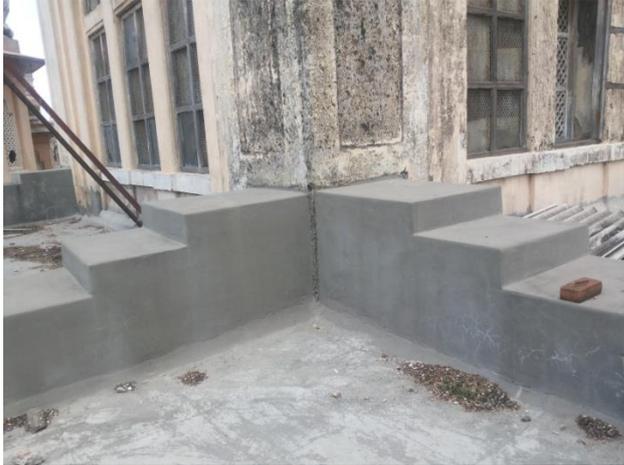
Interventions in cement

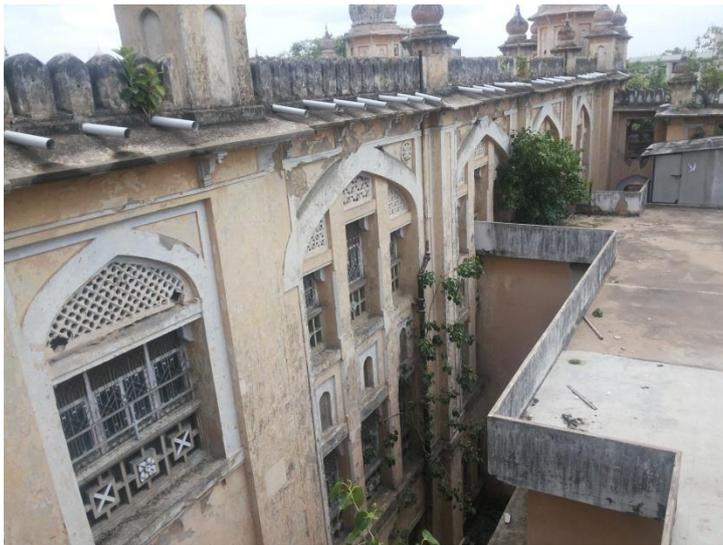
Later additions

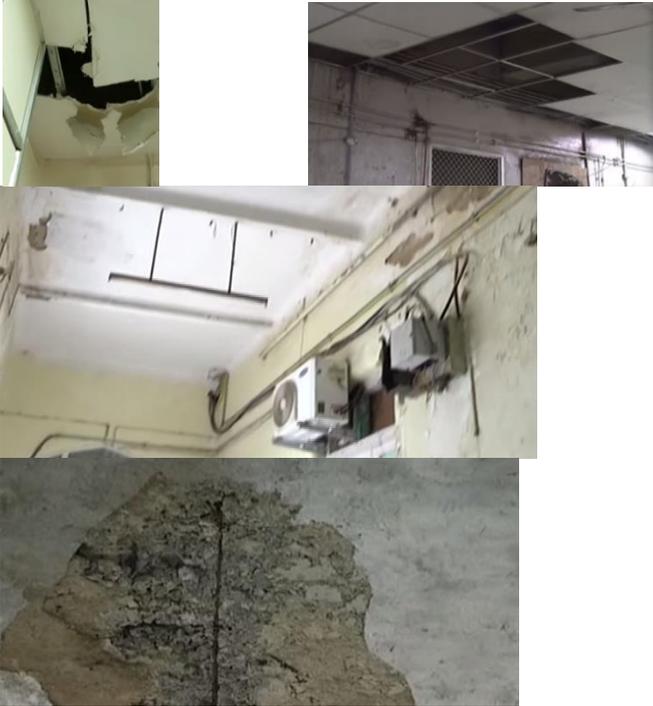
<p>False ceilings, Damaged Ceiling Plaster, Slab reinforcement damage.</p>	<p>Continued humidity and water seepage from leaking pipes.</p>	<p>Treatment to rusted reinforcement, removing the damp portions of the ceiling plaster and re- plastering using appropriate mortar mix. Repairs of leakages in pipes and terrace.</p>

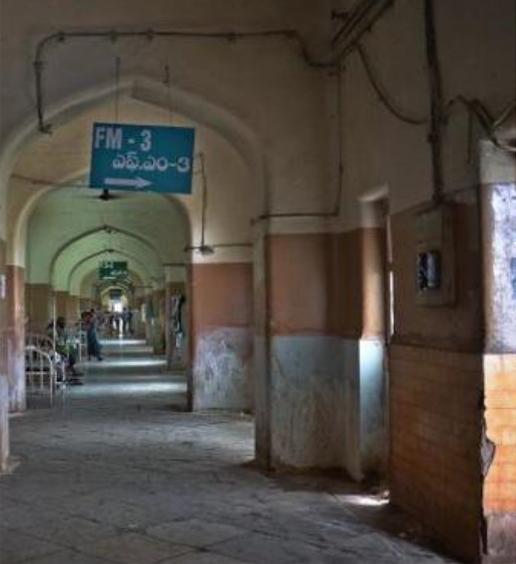
<p>Wall Plaster</p>	<p>Repaired plastering with non- porous cement over masonry in lime mortar causing cracks and humidity and damaging finishes.</p>	<p>Waterproofing using formulated plasters with air-entraining admixture or use traditional ingredients and techniques, particularly those employing a lime and sand mix.</p>

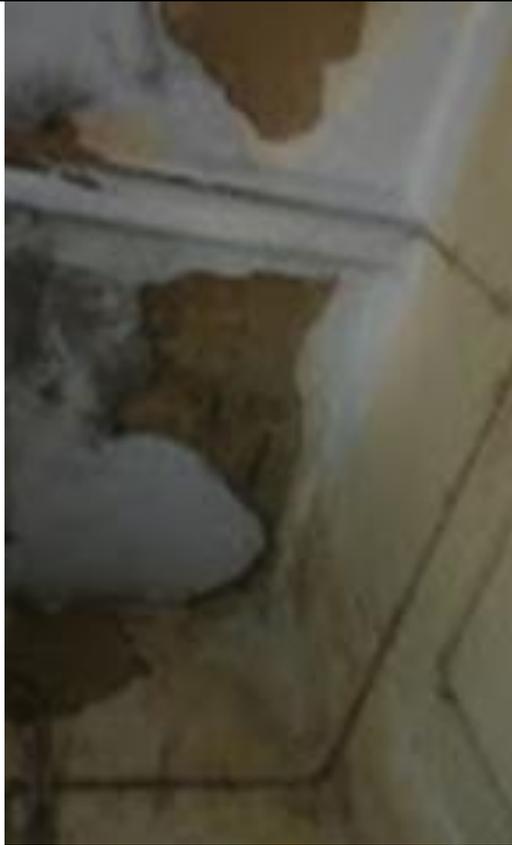
<p>Seepage of water & Dampness, Water Logging</p>	<p>Water logging on terrace. Failure of water proofing layer on the terrace or improper technique/ material employed for water proofing.</p>	<p>Roofs can be re water proofed by using polymer-based flexible waterproofing systems by removing the existing top repaired layer without disturbing the structural stability and maintaining required slopes. For waterproofing and sealing purposes - injection grouting by using suitable and compatible grouting systems, regular maintenance, repairs to water outlets and spouts joints as well as removal of vegetation and debris from the terraces.</p>

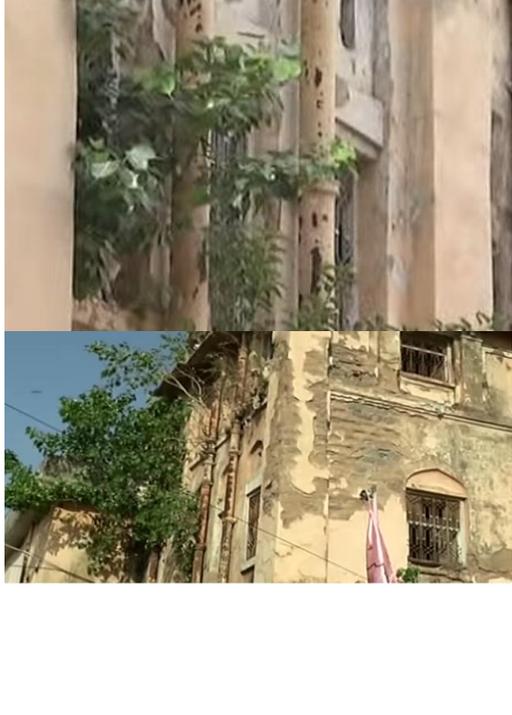
<p>Vegetative/ Moss , biological Growth</p>	<p>Growth due to continued dampness of surface because of water logging and lack of attention and periodical cleaning and removal.</p>	<p>Cleaning and removal of existing biological growth at bottom portions and coating the same with fungicides or weedicide to avoid the recurrence and also providing proper slopes while laying the new terrace to allow water run-off easily.</p>

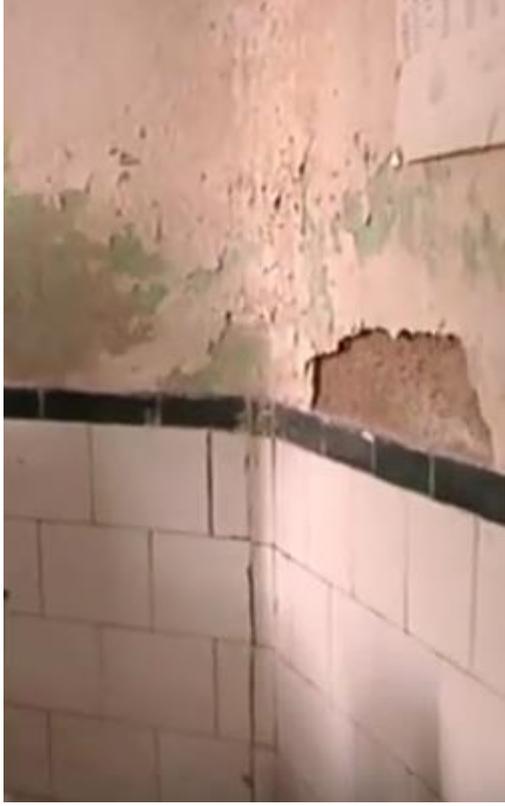
<p>Flaking of Plaster in wet areas.</p>	<p>Flaking due to continued dampness in wall because of water seepage from roof or because of raising dampness from below.</p>	<p>Repairs to leaking pipes - thereafter Water proofing of plasters can be done. Rising dampness to be treated by creating damp proofing course by using appropriate / proper compounds and admixtures.</p>

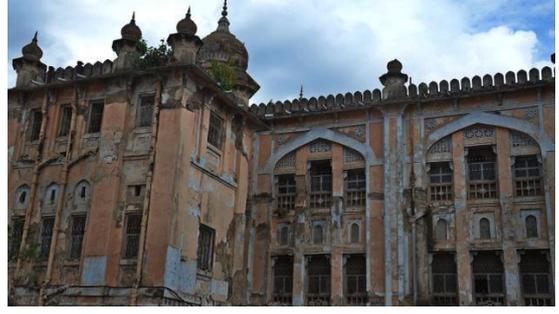
<p>Cement and other material additions</p>	<p>Cement addition is unfavorable to a lime construction structurally.</p>	<p>Removing earlier repaired portions using high strength cement without causing any sort of damage to the structure and strengthen it by re-doing those portions using harmonizing lime mortar mixes. In areas where major repairs are to be done opt for use of polymer mortars by incorporating acrylic or latex based admixture.</p>

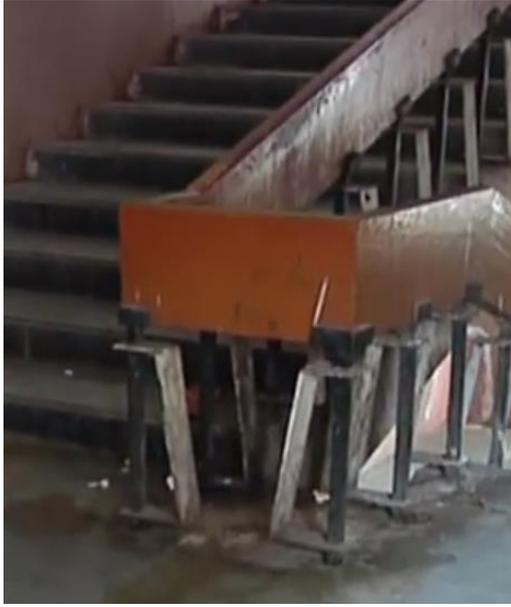
<p>Floorings and surface bases. Treads for steps.</p>	<p>Unmatched and incompatible building materials compared to those originally used. Damages and wear and tear.</p>	<p>Localised repairs to highly damaged floors in original materials. For rest - work can be taken up in phases as per overall restoration strategy.</p>

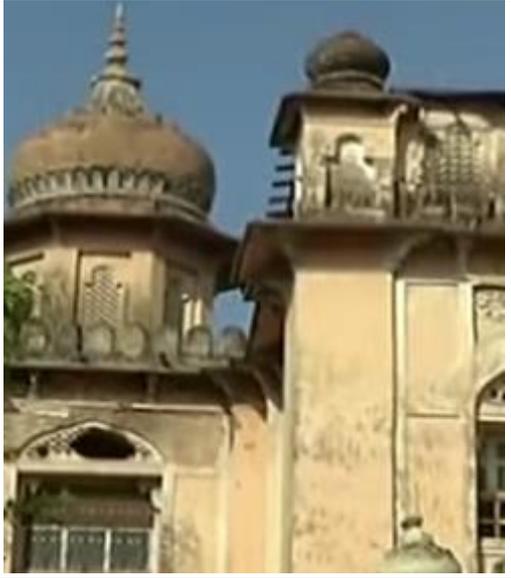
<p>Doors ,Windows & Ventilators; Openings.</p>	<p>Additional openings executed for modifications and partitions - especially doors. Windows on exteriors</p>	<p>As the joineries are made of natural wood, these can be treated and part replaced and provided with protective coating replacing standard hardware. Opening of closed ventilators and windows for better ventilation</p>

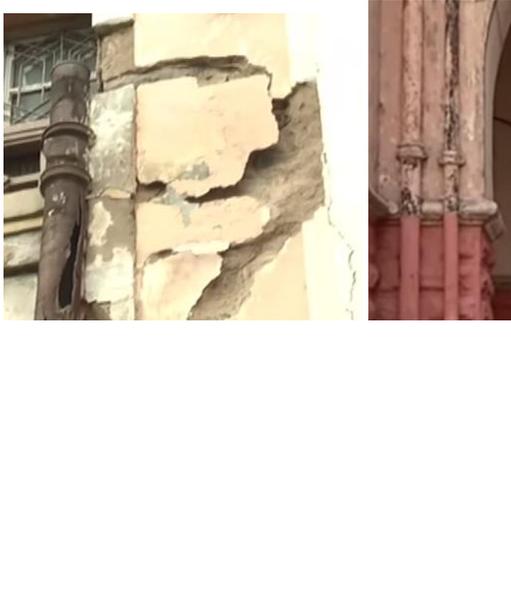
<p>Plumbing Services & Installations,</p>	<p>The main cause for water, especially drainage water creating dampness and damage to surface finishes and slab. Lacks maintenance.</p>	<p>As immediate measure leaking and broken pipes to be replaced, thereafter installation of building services, mainly sanitary and plumbing system with integrated design approach ensuring proper collaboration to avoid damage to structure.</p>

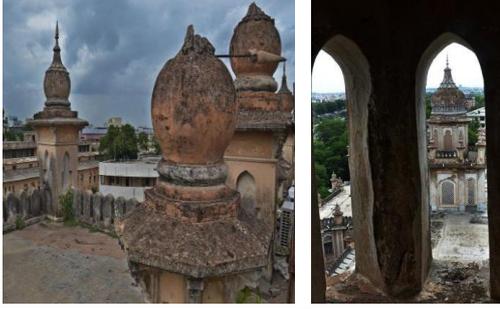
<p>Minars, parapets and architectural elements</p>	<p>Lack of maintenance and weathering.</p>	<p>As these elements are in brick they can be repaired, re-constructed with compatible bricks and binding/plastering as per overall conservation strategy</p>

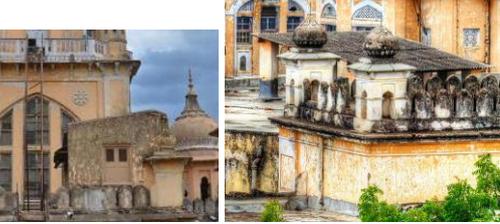
<p>Alterations and additions with no relevance.</p>	<p>Extra unprotected brick walls, rooms, OHT, etc., found in some places.</p>	<p>Removal of all walls and other constructions without relevance to heritage structure. Removal of unwanted equipment and debris. Finish the surfaces and base with compatible materials</p>

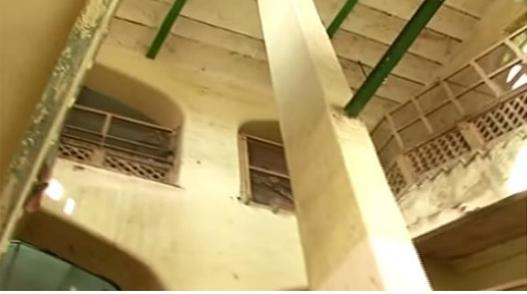
<p>Stair Cases and lifts, machine rooms.</p>	<p>Improper maintenance of elevators and some damage to stair case due to dampness</p>	<p>Strengthening is required to make it structurally safe by reconstruction of some parts. The lift which is abandoned can also be restored.</p>
